DEPARTMENT OF TRANSPORTATION

Contract #: 04-0120F4Cty: SF/ALA Rte: 80 PM: 13.2/13.9File #: 69.28**WELDING INSPECTION REPORT****Resident Engineer:**Siegenthaler, Peter**Address:** 333 Burma Road**City:** Oakland, CA 94607**Report No:** WIR-018961**Date Inspected:** 14-Dec-2010**Project Name:** SAS Superstructure**OSM Arrival Time:** 700**Prime Contractor:** American Bridge/Fluor Enterprises, a JV**OSM Departure Time:** 1900**Contractor:** Zhenhua Port Machinery Company, Ltd (ZPMC), Changxing Island **Location:** Shanghai, China**CWI Name:** Mr. Xu Le Feng**CWI Present:** Yes No**Inspected CWI report:** Yes No N/A**Rod Oven in Use:** Yes No N/A**Electrode to specification:** Yes No N/A**Weld Procedures Followed:** Yes No N/A**Qualified Welders:** Yes No N/A**Verified Joint Fit-up:** Yes No N/A**Approved Drawings:** Yes No N/A**Approved WPS:** Yes No N/A**Delayed / Cancelled:** Yes No N/A**Bridge No:** 34-0006**Component:** Tower / OBG**Summary of Items Observed:**

WELDING INSPECTION REPORT

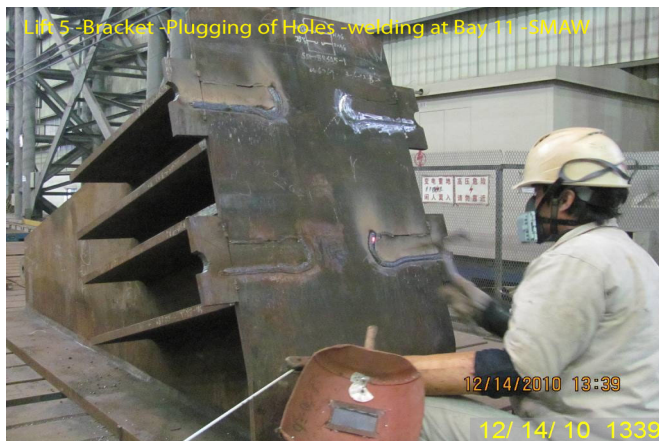
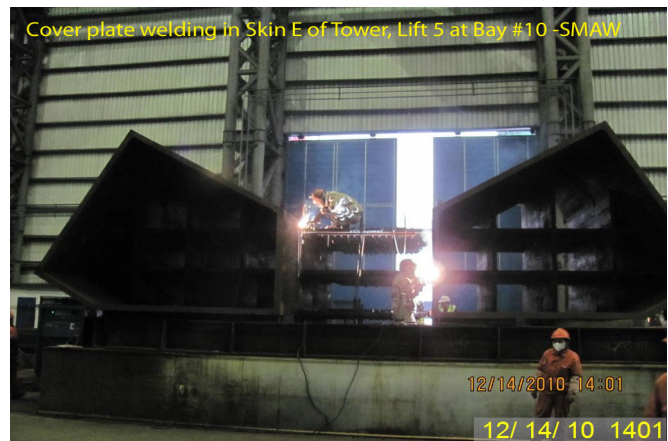
For further information see below pictures:-

Unless otherwise noted, all work observed on this date appeared to be in general compliance with the applicable contract documents.
